Peter Driver report - Comparison of Road Signage at Horsmonden and Benenden

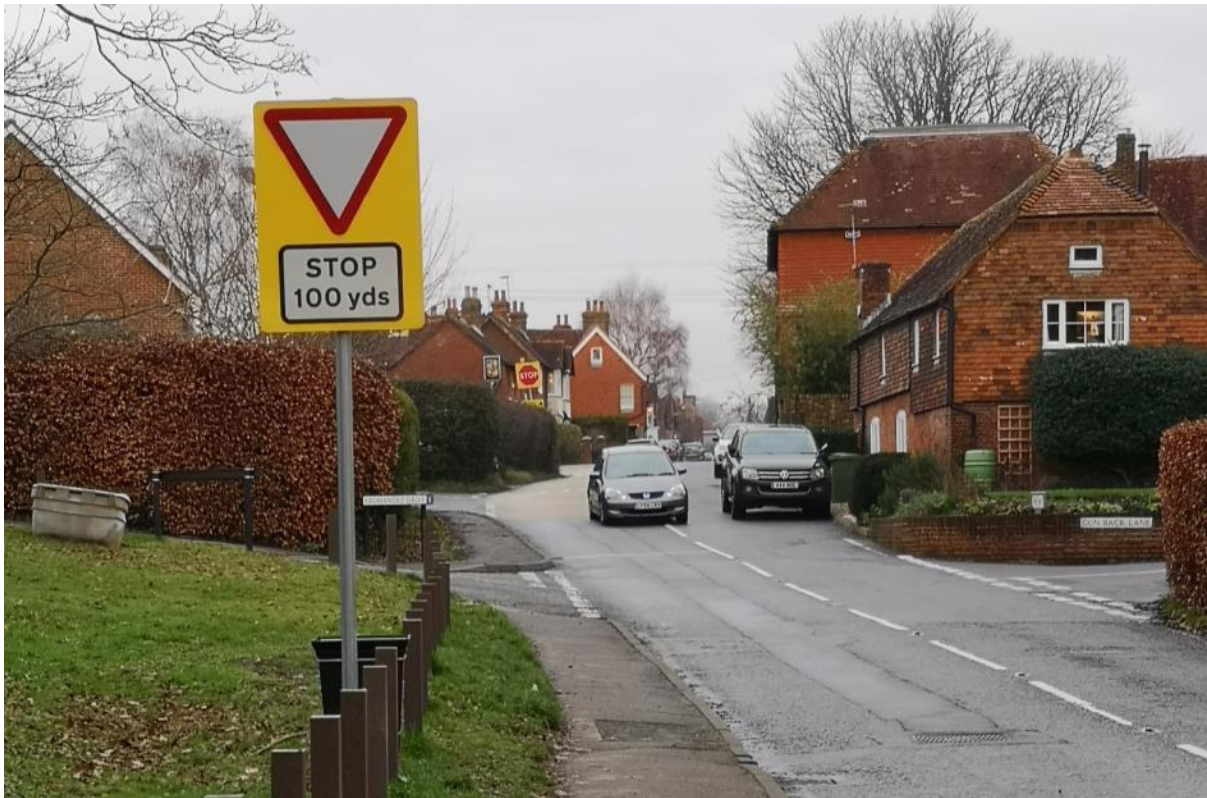
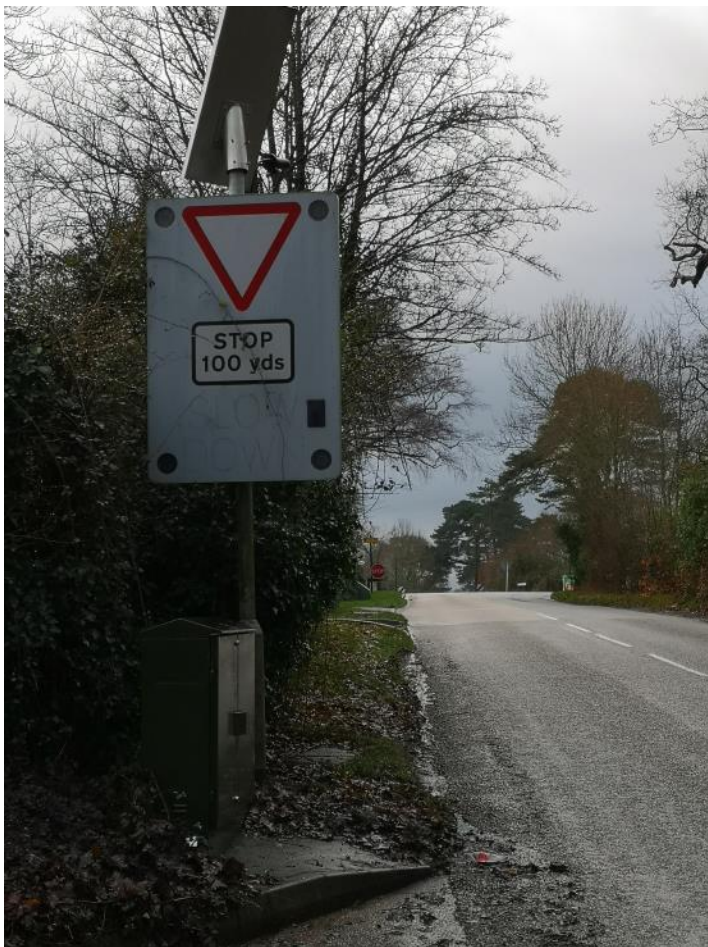
Benenden Vehicle Activated Slow Down sign not working . Grey backing board and solar panel adds to the general cluttered feel. Sign is high to avoid being hidden by 30 mph roundels (see later photograph).

The STOP sign at Benenden crossroads is just visible here.

Compare with the visibility of the signs at Horsmonden (both 100 yards and STOP sign at junction can clearly be seen)

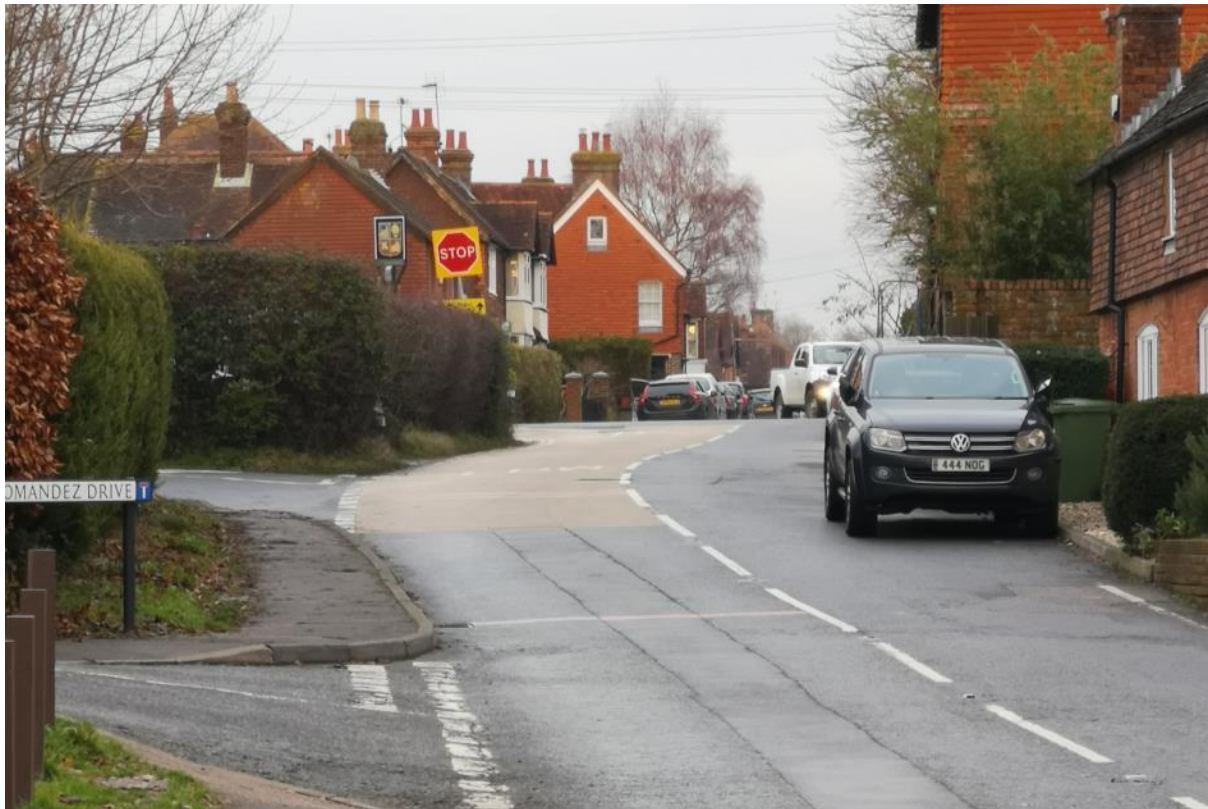
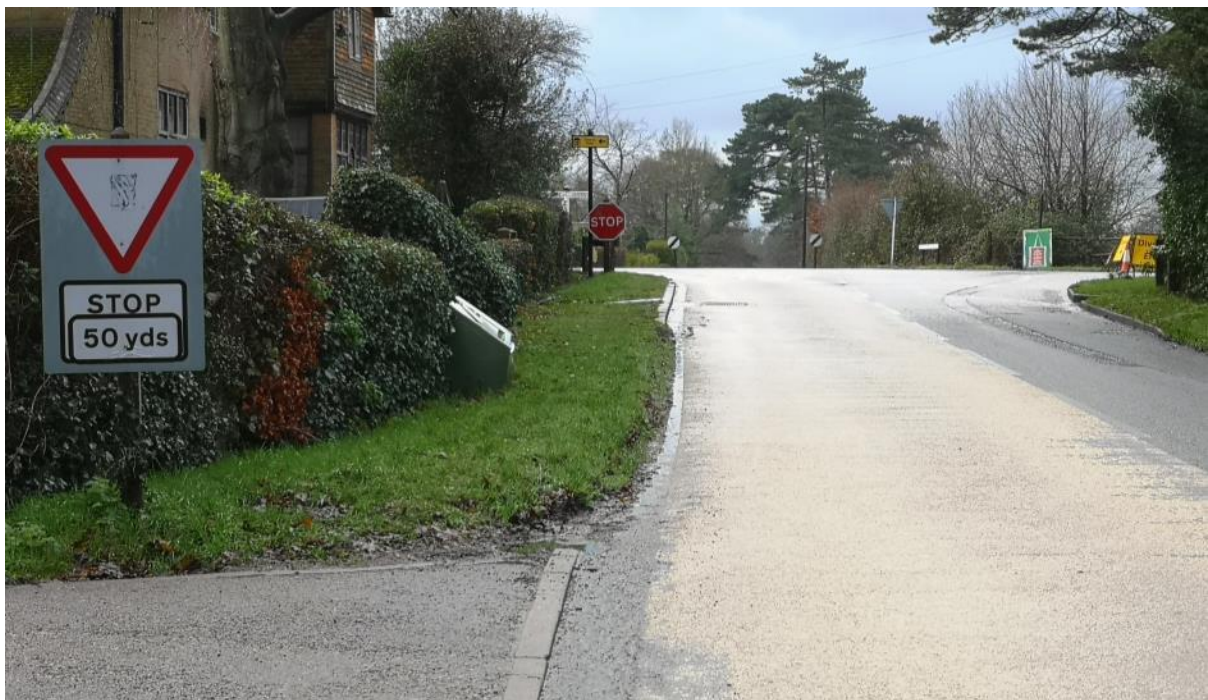
The STOP 50 yards sign at Benenden has been damaged by a fly poster which reduces reflectivity. It is sited on the extreme left of the verge to avoid obstructing sightlines for vehicles emerging from Hortons Close which also means it does not have the recommended 60 m of clear visibility. I'm not sure if the additional 50 yards plate conforms to standards (I doubt it does)

No equivalent sign exists at Horsmonden

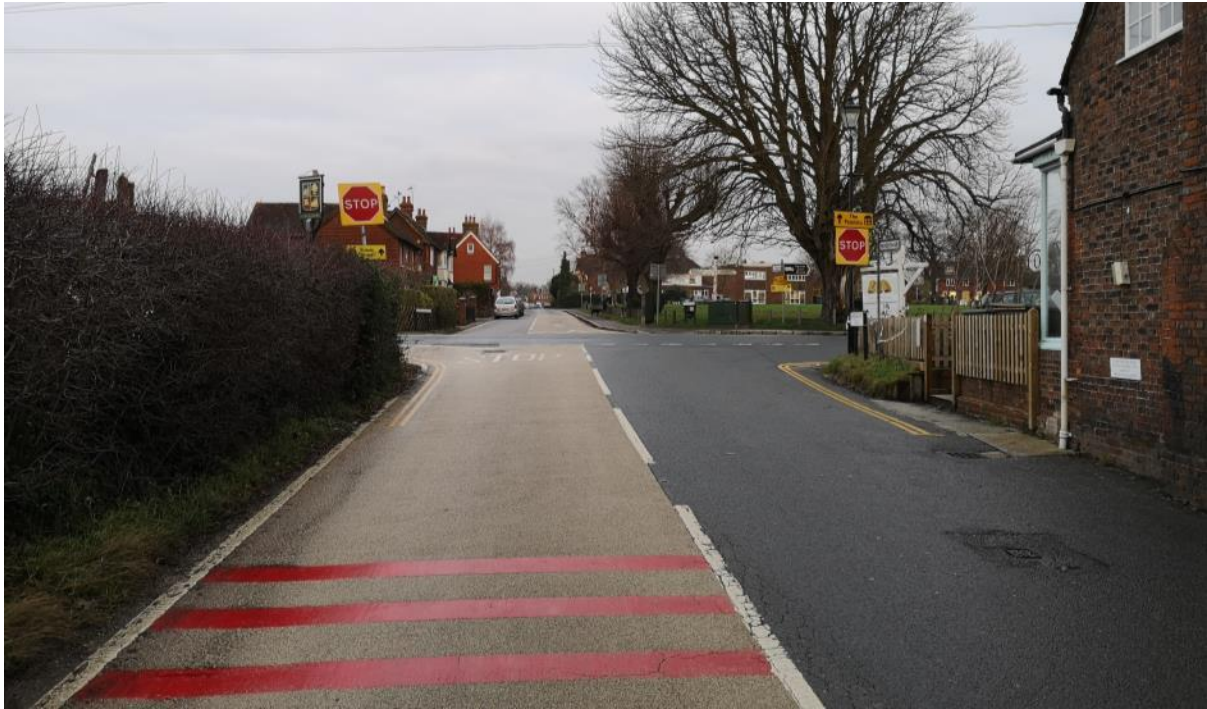
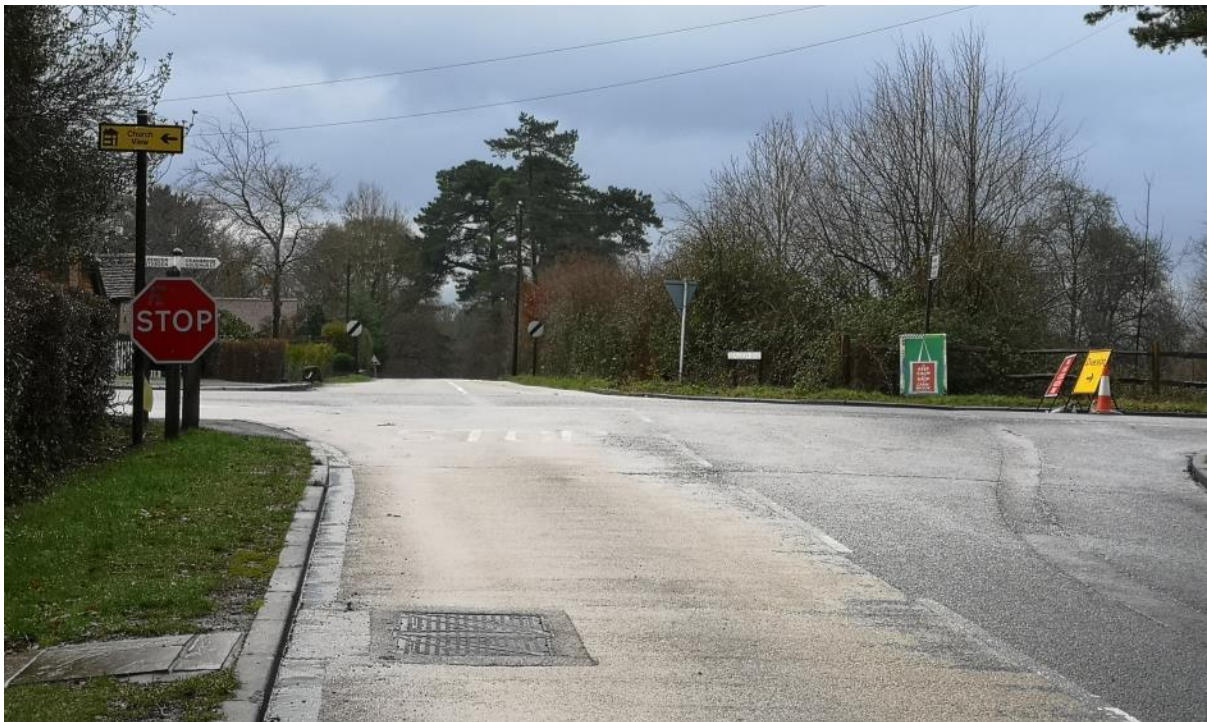
The octagonal STOP sign at the Benenden junction has also been damaged by a fly poster which must reduce reflectivity. It is mounted on a low wooden post.

The Horsmonden octagonal has a bright yellow backing board and there are signs on each side of the road. The sign on the right hand side is largely hidden until the junction is almost approached so I'm not sure it adds much value. A similar situation would occur at Benenden where a sign on the right would be largely obscured by hedging.

Both are blighted by development signs, the Benenden sign being for housing in St Michaels!

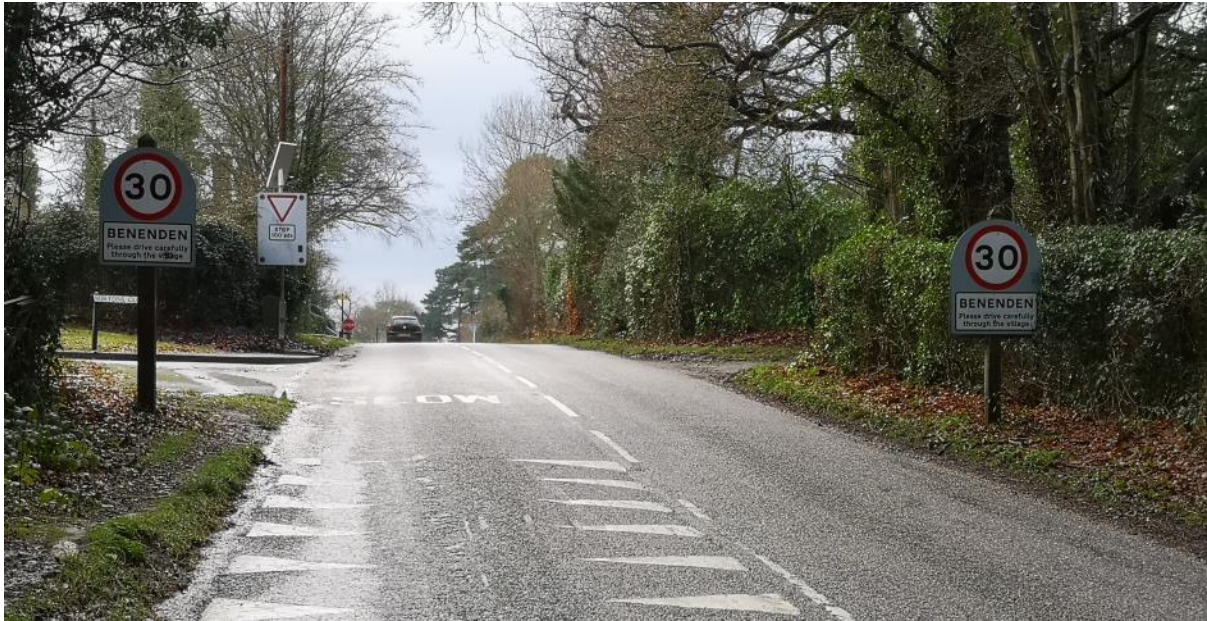
General scene showing all signage on the approach to Benenden crossroads (except for the “hidden” STOP 50 yds sign by Hortons Close). Below are close ups of the three Benenden signs
